**Flood Control Project Maintenance  
Levee Inspections**

**Fall 2009 Levee Maintenance Deficiency Summary Report**

**Sacramento Maintenance Yard Putah Creek**

**Levee Inspection Report By Mile - Fall 2009**

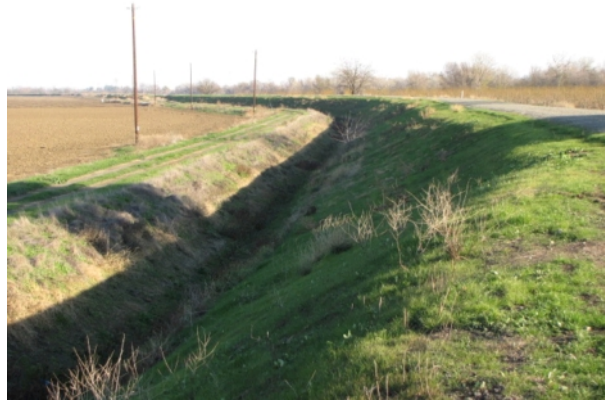
phillips\_20091216\_31.jpg

Levee Mile Report Line	5
Start Levee Mile	1.55
End Levee Mile	2.72
Location	Land Side
Category	Earthen Levee
Item	Encroachments

This ditch is located within the 10-foot easement and has been at this location for several years.

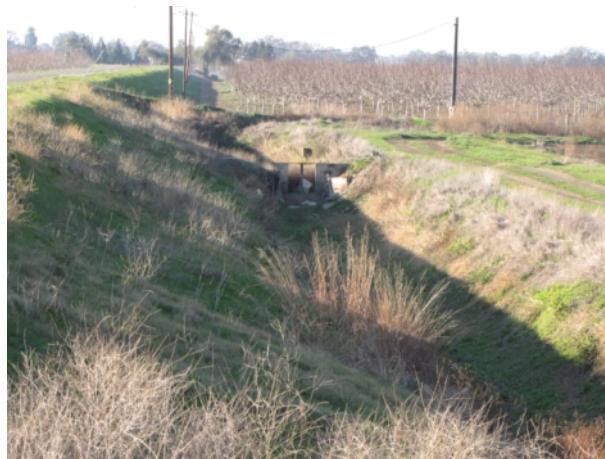
phillips\_20091216\_32.jpg

Levee Mile Report Line	5
Start Levee Mile	1.55
End Levee Mile	2.72
Location	Land Side
Category	Earthen Levee
Item	Encroachments

Another view of ditch looking downstream landward.

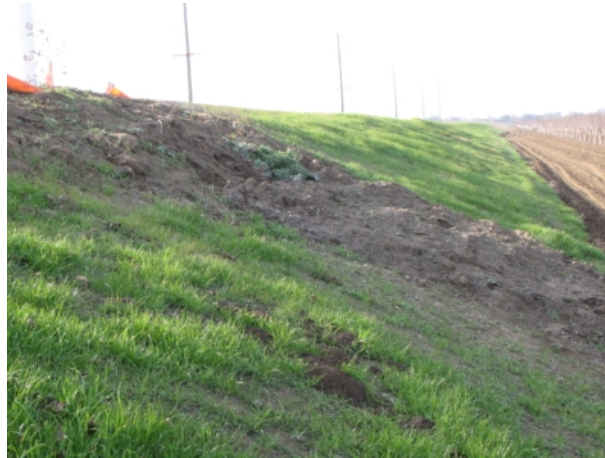
phillips\_20091216\_28.jpg

Levee Mile Report Line	4
Start Levee Mile	1.09
End Levee Mile	1.10
Location	Water Side
Category	Earthen Levee
Item	Erosion / Bank Caving

Photo shows partial repair of slope damage.

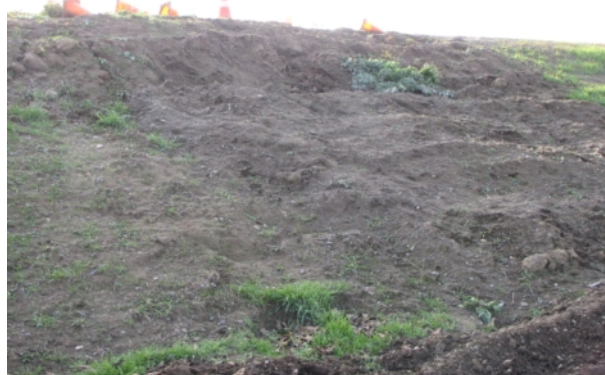
phillips\_20091216\_29.jpg

Levee Mile Report Line	4
Start Levee Mile	1.09
End Levee Mile	1.10
Location	Water Side
Category	Earthen Levee
Item	Erosion / Bank Caving

slope damage some repairs made. Proper repair need to be done at this site with compaction test to verify compaction.

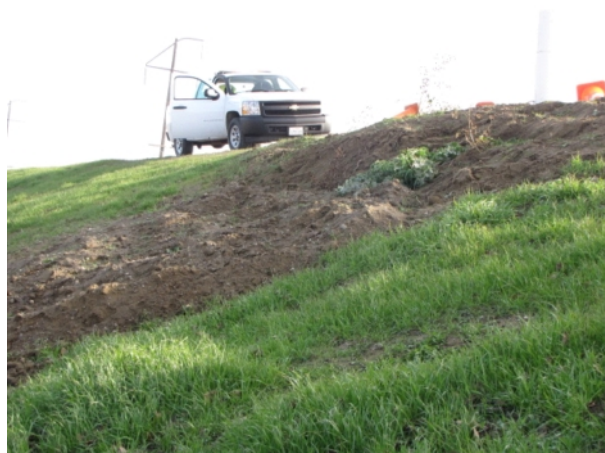
phillips\_20091216\_30.jpg

Levee Mile Report Line	4
Start Levee Mile	1.09
End Levee Mile	1.10
Location	Water Side
Category	Earthen Levee
Item	Erosion / Bank Caving

Another view standing on toe of slope looking upstream.
